# Manhole Inspection Summary

Manhole # S47I2\_015MH

**Location** Address: **Elmtree St.**

Cross Street: **Pennington-Morrison**

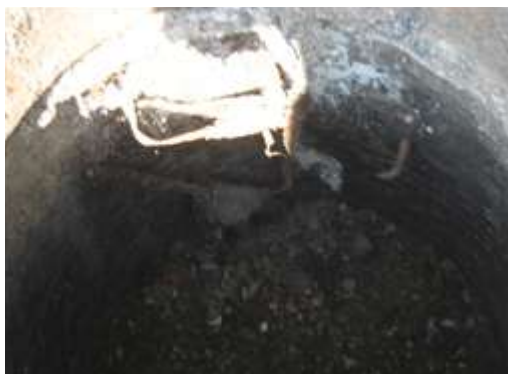
Steps

**Steps** Count: **4** Missing: **2** ☐ Corroded

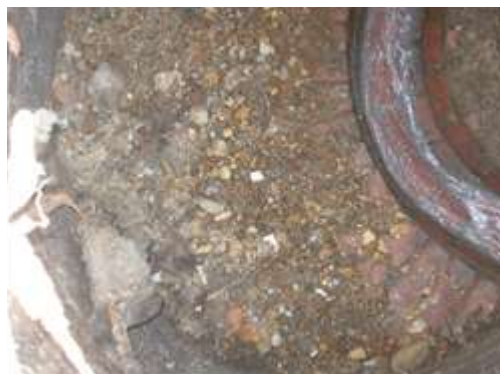
Defect 1

Debris on bench

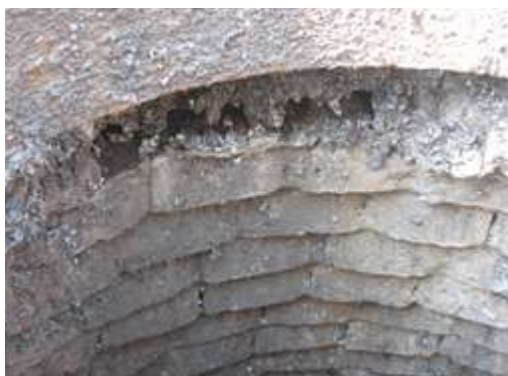
Defect 2

Condition: ☐ Sound ☐ Cracked ☐ Root Intrusion ☐ Loose Brick ☒ **Deteriorated**

Infiltration: ☐ None ☐ Joint ☐ Cracks ☐ Mortar ☐ Roots ☒ **Wall**

Missing Bricks in Chimney

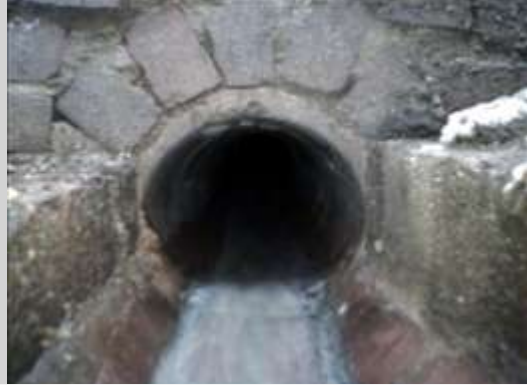
12 O'Clock Outflow

8 in. Circular Gravity Sewer  
Pipe Out @ 12 O'Clock

Pipe Height: **8.4** (in.) Rod and Bar (Angled)  
Pipe Material: **Clay** ☐ Pipe Lined  
Invert Depth: **7.48** (ft.) Flow Characteristics: **Fast**  
Deposits: ☒ None ☐ Mud ☐ Sludge ☐ Debris ☐ Grease  
Silt Depth: (in.) Deposits Extent:  
Infiltration: **None** Pipe Seal Cond: **Sound**

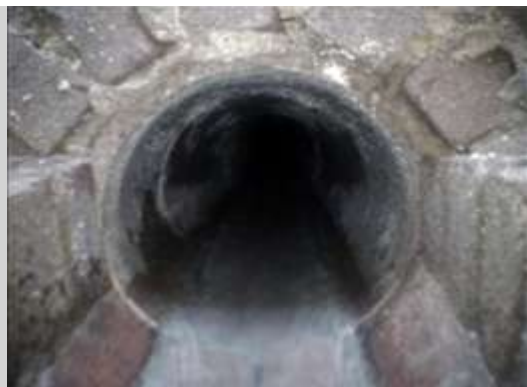
3 O'Clock Inflow

8 in. Circular Gravity Sewer  
Pipe In @ 3 O'Clock

Pipe Height: **8.4** (in.) Rod and Bar (Angled)  
Pipe Material: **Clay** ☐ Pipe Lined  
Invert Depth: **7.18** (ft.) Flow Characteristics: **Fast**  
Deposits: ☒ None ☐ Mud ☐ Sludge ☐ Debris ☐ Grease  
Silt Depth: (in.) Deposits Extent:  
Infiltration: **None** Pipe Seal Cond: **Sound**
